# A Review on Failures of Industrial Components due to Hydrogen Embrittlement & Techniques for Damage Prevention

## Abstract

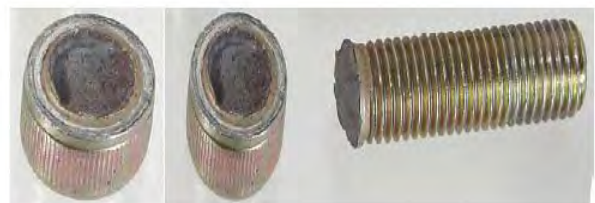
**Figure 1.** Typical Fastener Failure by Hydrogen Embrittlement [8]

High strength mechanical steel fasteners are broadly characterized by tensile strengths in the range of 1,000 – 2,000 MPa (150 – 300 ksi), and are often used in critical applications such as in bridges, vehicle engines, aircraft, where a fastener failure can have catastrophic consequences. [7]When high strength steel is tensile stressed, as is the case with a high strength fastener that is under tensile load from tightening, the stress causes atomic hydrogen within the steel to diffuse (move) to the location of *greatest stress* (e.g., at the first engaged thread or at the fillet radius under the head of a bolt). As increasingly higher concentrations of hydrogen collect at this location, steel that is normally ductile gradually becomes brittle. Eventually, the concentration of stress and hydrogen in one location causes a hydrogen induced (brittle) micro crack. The brittle micro crack continues to grow as hydrogen moves to follow the tip of the progressing crack, until the fastener is overloaded and finally ruptures.

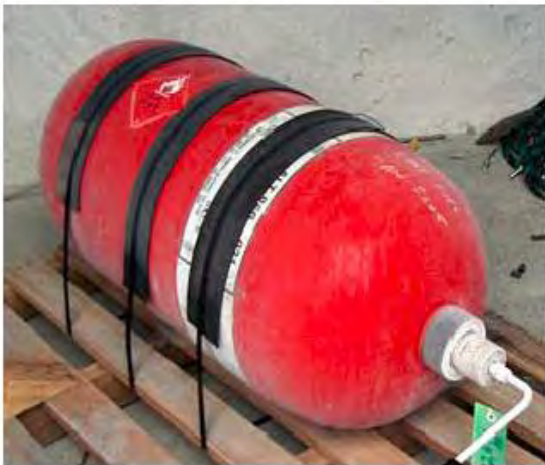
**Figure 2.** High Pressure Hydrogen storage tank [6]

Currently, austenitic stainless steel AISI 316 (SS 316) is the predominant material of construction for high-pressure hydrogen components and tubing, and has recently been incorporated into the construction of high-pressure hydrogen storage tank liners. A type- III storage tank consists of a metallic liner fully wrapped in glass or carbon fibres<sup>1</sup>. The main function of the fibre is to provide the strength required to contain the pressure. Tanks with higher storage pressure capacity will typically use a carbon fibre wrap because glass fibres can be susceptible to stress corrosion cracking. The principal function of the liner is to prevent escape of the gas,

although it would also offer /contribution to the overall strength. On average, metallic liner materials are expected to sustain about 20% of the load imparted during pressurization1. It is important for the liner material to have low permeability of hydrogen for containment of the gas, high toughness for impact resistance, and resistance to corrosion and hydrogen embrittlement, The research result most relative to the field of material testing and certification for use in the hydrogen industry is that hydrogen environment embrittlement is dominant at the material surface. Once a crack forms, a constant supply of hydrogen to its tip will facilitate propagation via the de-cohesion model of hydrogen embrittlement.[6]

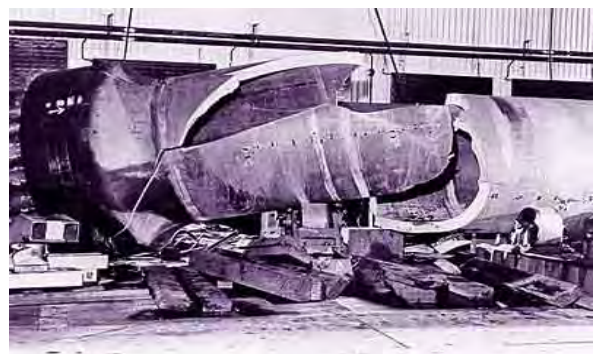
**Figure 3 (a,b).** Failure of weldment [9]

In high strength steel weldments, hydrogen is introduced by the arc of welding and diffuses to the heat affected zone where susceptible microstructures such as martensite and bainte are present. This causes hydrogen embrittlement. At critical residual stress, the Hydrogen Induced Cold Cracking (HICC) occurs. Thus, HICC occurs due to three factors: i) a susceptible microstructure; ii) sufficiently high concentration of diffusible hydrogen and; iii) a critical stress intensity.

[9] Hydrogen cracking may also be called cold/ delayed cracking. During the welding process, hydrogen is introduced to the weld metal from the moisture or other hydrogenous compounds in the electrode, the covering flux, atmosphere and the weld material. A part of hydrogen diffuses out of weldments during the solidification, another part is trapped in hydrogen traps such as dislocations, grain boundaries, inclusions etc, and the third part diffuses to the Heat Affected Zone (HAZ). This causes Hydrogen Embrittlement (HE) of HAZ microstructure. In low alloy steels, fast cooling rate in the HAZ usually generates hard

microstructures such as martensite, bainite which are extremely susceptible to HE. Thus, HICC occurs in the HAZ under local residual stress or restraint stress.[10]
